GP Friel Ltd.

Moir St Stormwater  
Culvert Emergency Repair

CCNZ Award Entry

*March 2019*

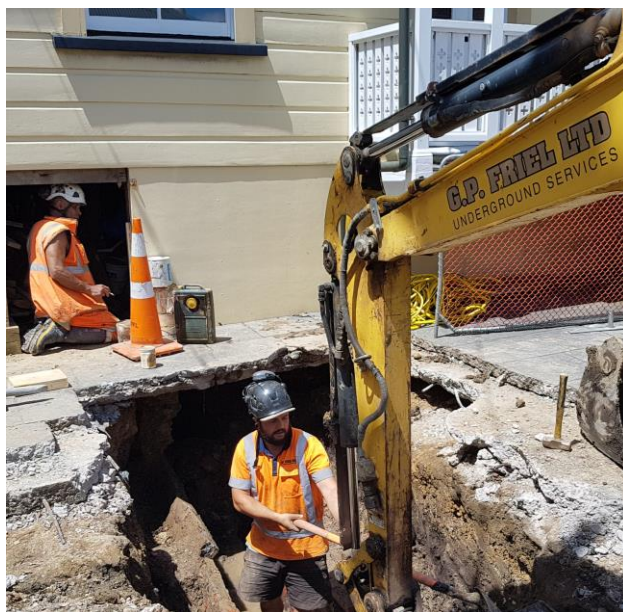
*Charlie & Cody cleaning up the damaged culvert*

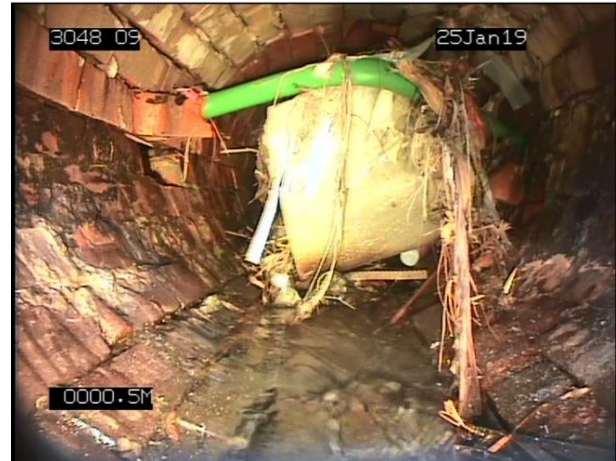
The asset had been blocked with debris that was caught on a communications service that had been drilled through the culvert. The resulting blow out undermined some of the foundation piles of the house, undermined the driveway and lifted the concrete footpath. It caused debris to blow out into the basement and into the street. A bit of a mess.

*CCTV showing the blockage in the existing culvert*

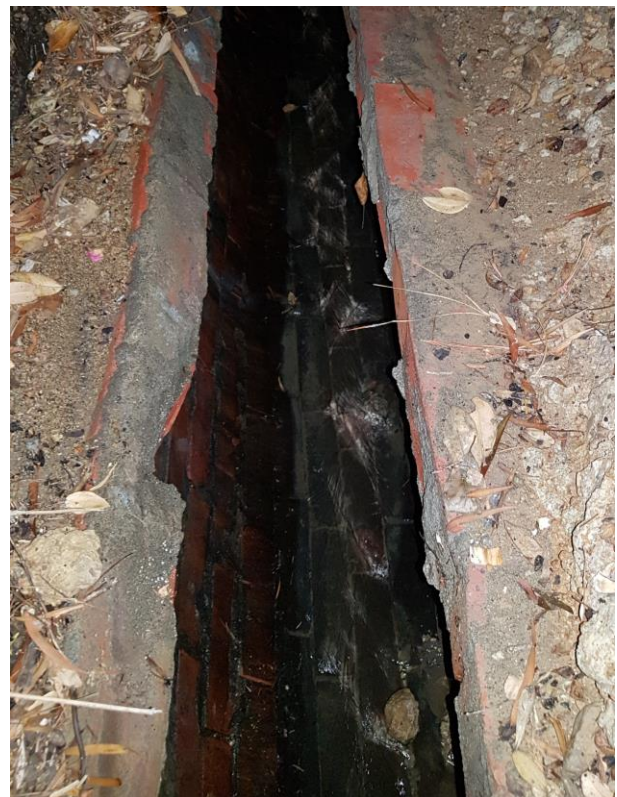
On the night of Wednesday 23<sup>rd</sup> January a rain event caused an existing brick culvert to blow out under a property in Moir St. The culvert was a 640mm dia. brick structure pre-dating the property that was constructed in 1892. An amazing piece of engineering that is at the end of it's life.

*The stormwater surge had blown out the top brick courses of the culvert into the basement of the house*

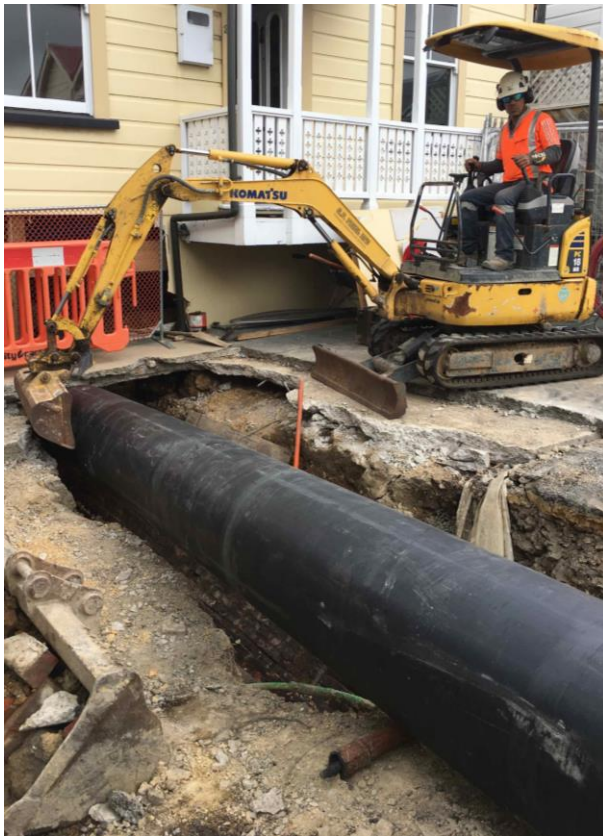
*The stormwater surge had blown out the top brick courses of the culvert into the basement of the house*

We engaged a specialist to assess the stability of the structure and install an arrangement to support the undermined piles off the adjacent piles. Once this was completed we were able to dig out the blockage, get the culvert flowing and create a launch pit to make an access into the culvert.

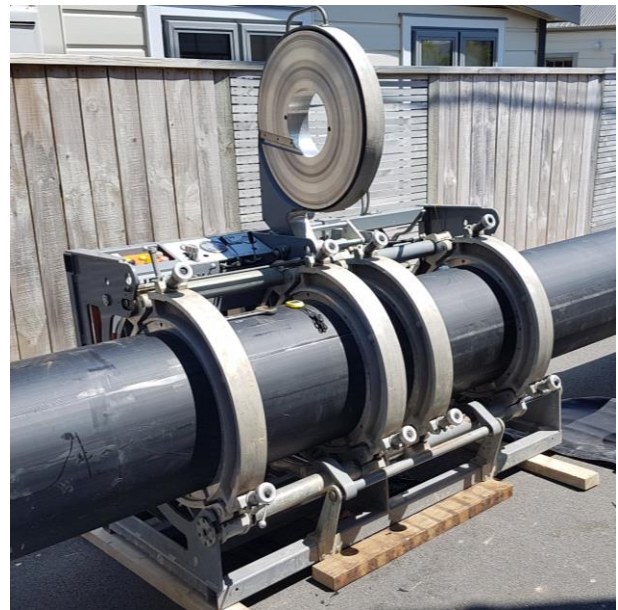
*560OD PE100 SDR17 being butt fusion welded*

GPFL slip lined the existing culvert with a 560OD PE100 SDR17 pipe – the largest that could be fitted. They enlisted the help of E Carson & Sons (ECS) to weld the lengths of pipe into one continuous string that could be pulled through the culvert. This task was a real challenge as there is no access to the upstream end of the existing culvert. A pipe of this diameter is fairly inflexible and the available space for a launch pit was limited. With a can do attitude and a bit of Kiwi ingenuity the team on site got the job done.

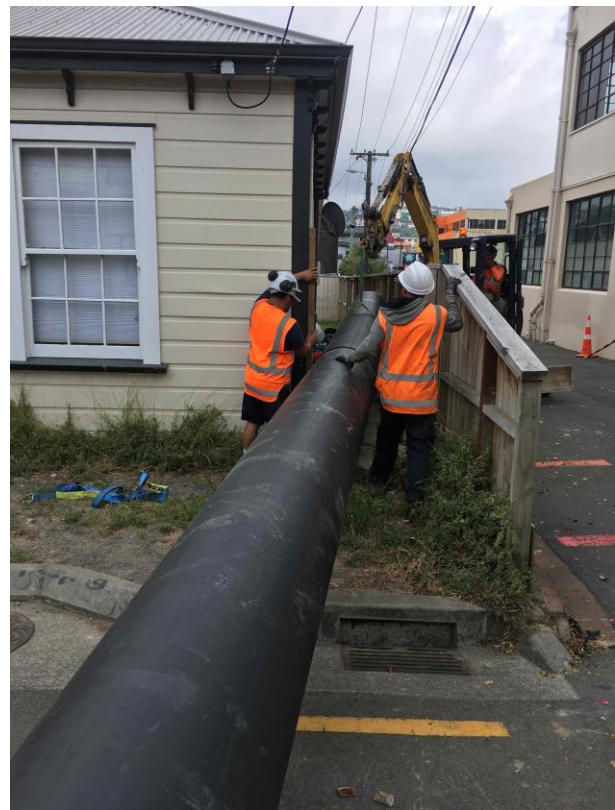
*Lindin, Tom & Gerry manoeuvring the new pipe around a neighbouring property*

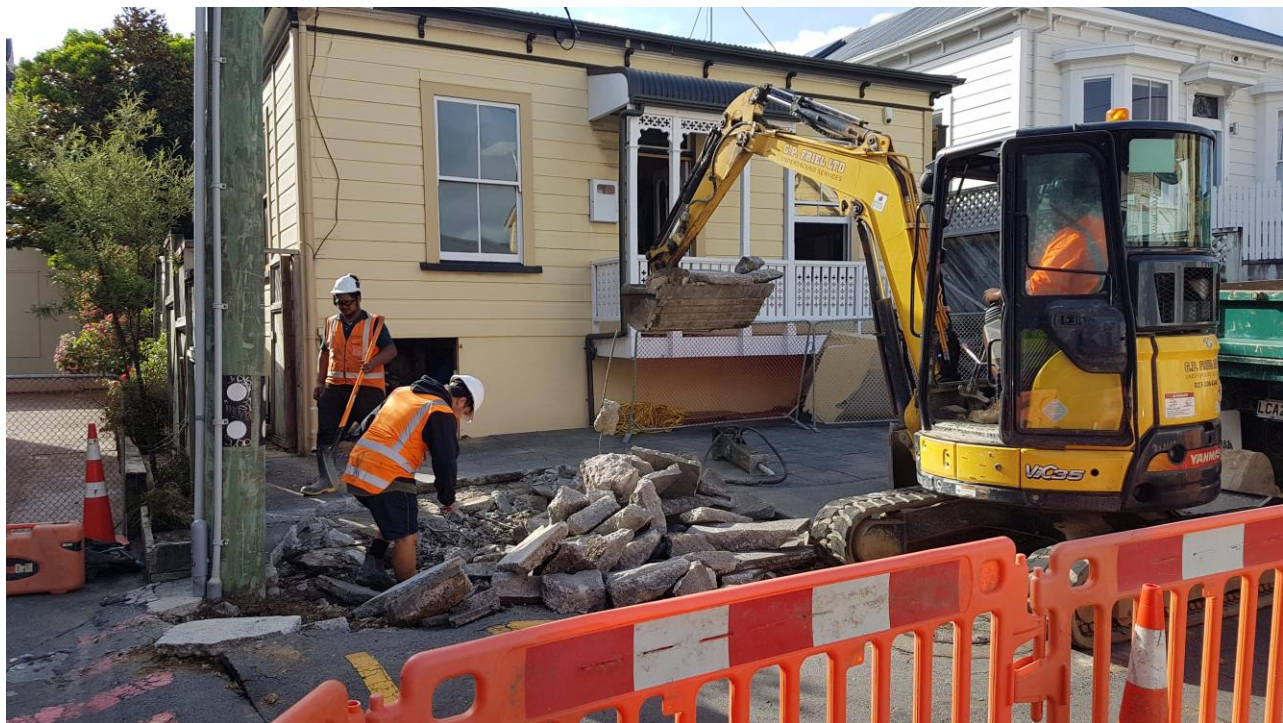
*Dan, Lindin & Cody excavating in a driveway to expose the damaged culvert*

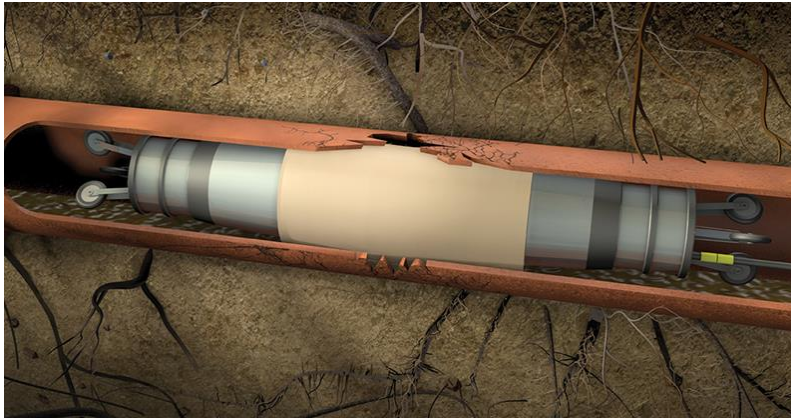
*Schematic of a CIPP Patch Liner being installed in a pipe*

Confined spaces were identified early in the delivery as a potential risk that would need to be managed. With no access to the upstream end of the repair; connecting the liner to the existing pipe and manhole was a bit of a puzzle. GPFL wanted to eliminate any requirement for a person to enter the pipe so we installed a CIPP patchliner to seal the liner to the existing culvert and manhole. An engineering solution that put People First.
